# TLICHO CHIMNEY PROJECT

July 13, 2010

Prepared by Carter Clarkson

In association with:  
The Tlicho Government, De Beers Canada & the University of British  
Columbia

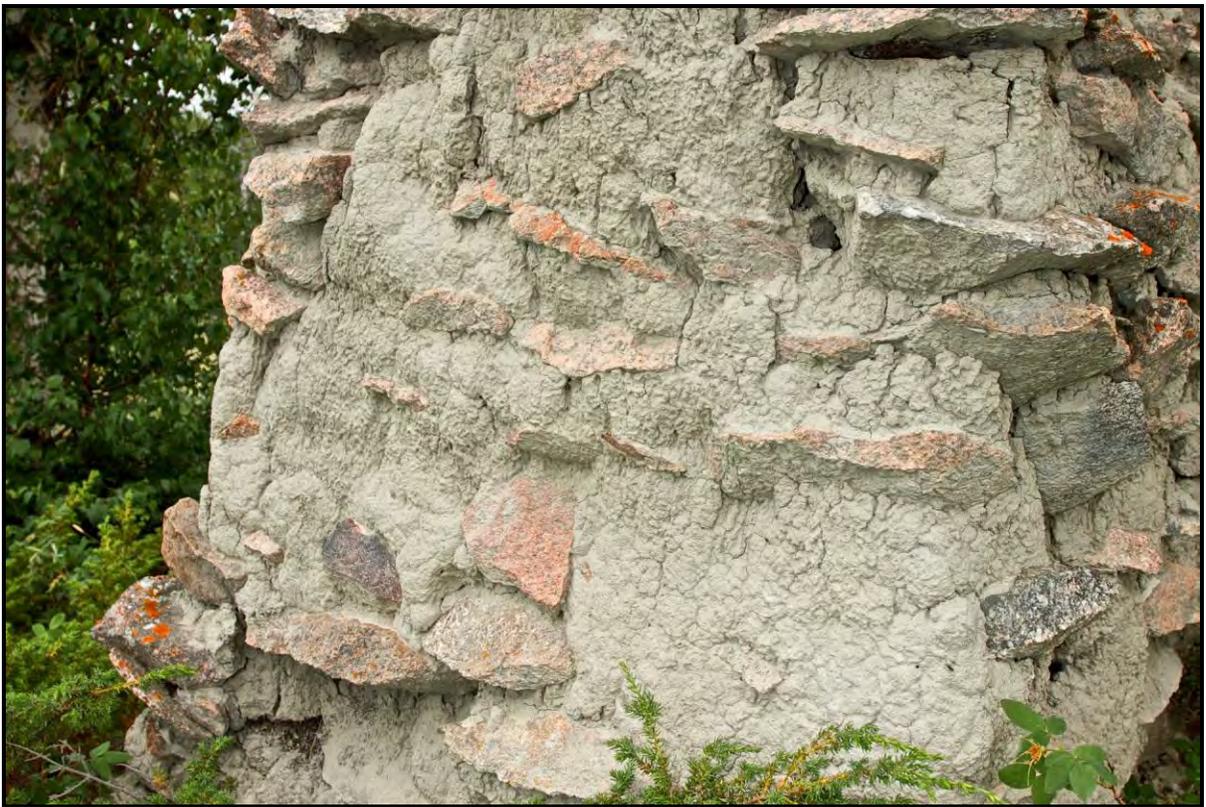
Figure 4.1

It is suspected that the mortar used in the construction of the chimney was clay retrieved from the nearby lake shore. For future construction the clay would need to remain saturated with water until it was needed. This would ensure the clay could be molded and no voids would be created. The chimney that was documented had a much higher ratio of mortar to rock than is seen in most traditional chimney/fireplace building (Figure 4.1). This could lead to the assumption that the clay mortar was more prevalent than rocks of satisfactory size and dimension.

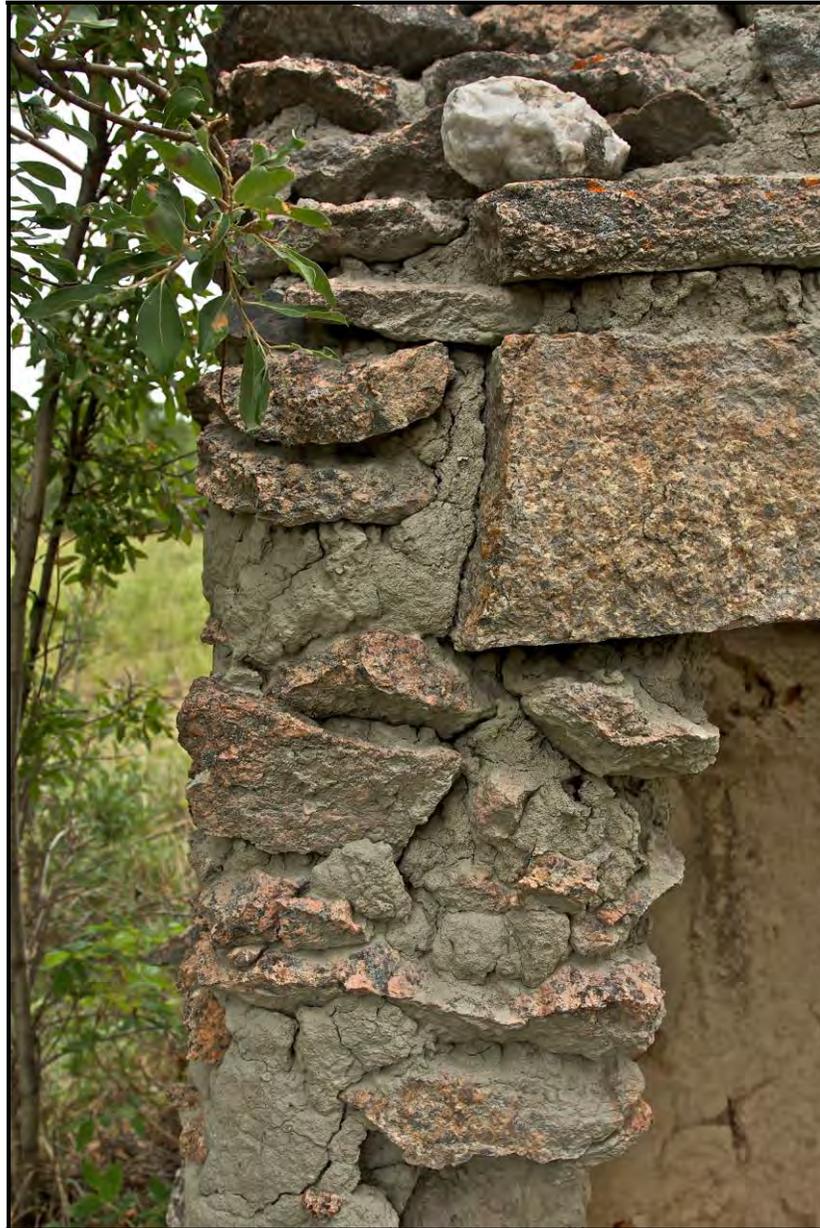
Figure 4.2

The chimney consisted of granitic rocks, the majority of which were relatively flat with square edges (Figure 4.2) and would have been chosen from the surrounding area. Larger rocks would have been used to construct a level base.

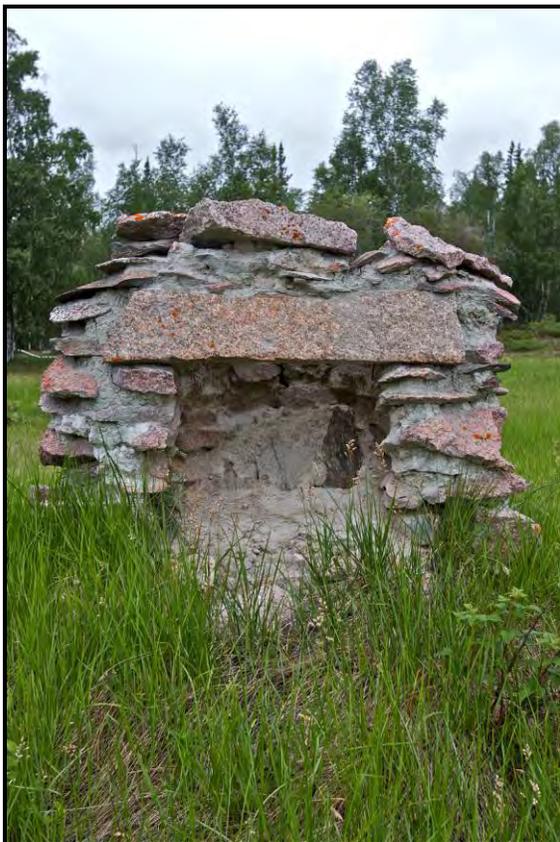
Figure 4.3

A key design feature of the chimney was the large rock over the opening in the fire place (Figures 4.3 and 4.4) hereon known as the “keystone”. This feature was prominent in the other chimneys located on the site and is key to the structure and functionality of the chimney design. Locating such a rock would be one of the key components in constructing a chimney. The rock selected would need to meet a variety of specifications including being wide enough to span the fireplace opening and thin enough for the chimney shaft to rise behind it.

With the size and weight of the keystone comes the need for a strong supporting structure below the rock on either side of the fireplace opening. During construction there should be an emphasis placed on ensuring the columns either side of the fireplace opening are constructed with a close attention to detail to limit voids between the mortar and rocks and to ensure a sufficient supporting structure.

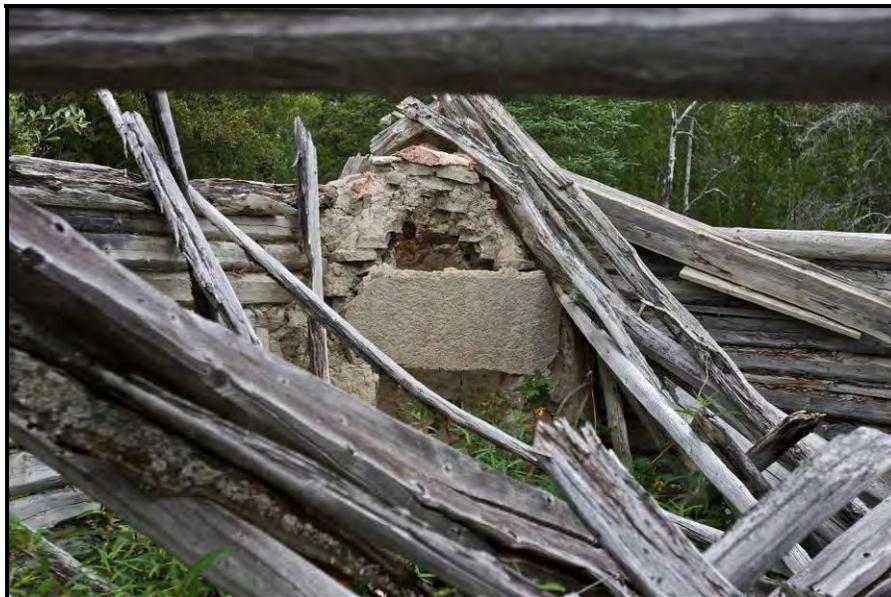
Figure 5.1

After observing the only chimney that remains upright within a standing cabin, it appeared as though the chimney had been constructed after the walls of the cabin were erected (Figure 5.1). Therefore, the walls of the cabin would aid in the construction of the chimneys and determine their final shape and structure. It would be essential the cabin be built on solid ground and as level and square as possible.

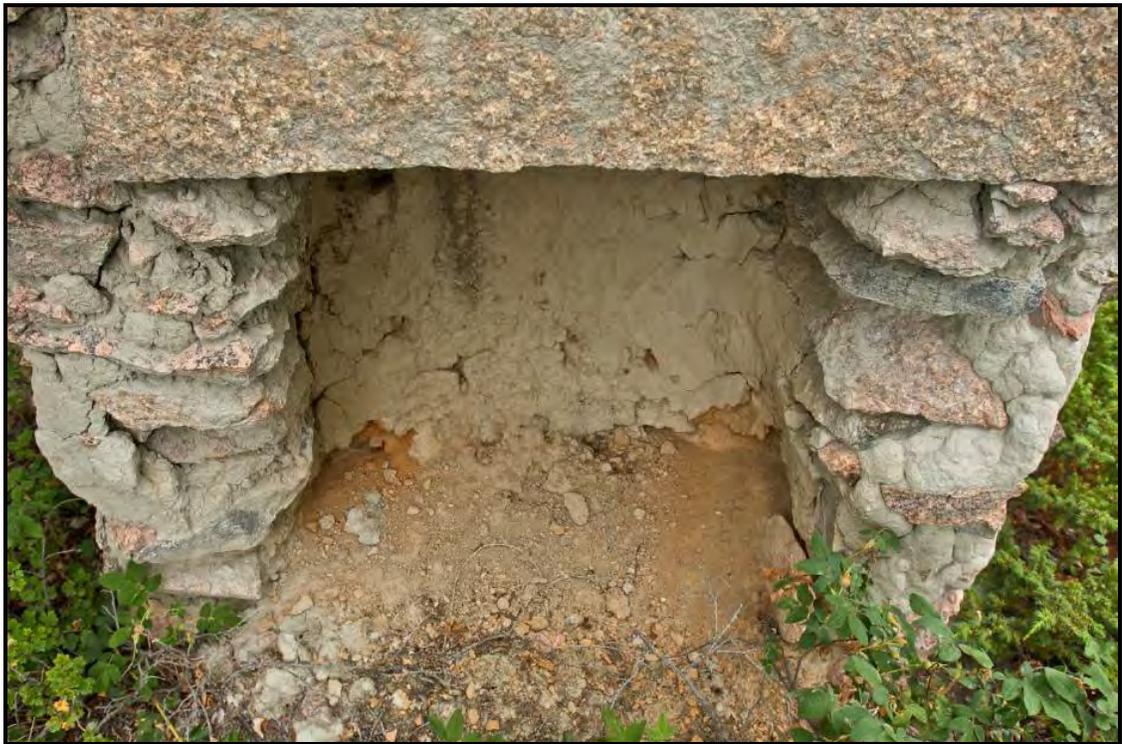
Figure 5.4

Throughout construction, ensure adequate amounts of mortar are placed between each rock. Construct the body in layers, starting at the back and leaving an area for the firebox. Ensure the columns on either side of firebox are robust. Work up level by level until the height of the top of the firebox is reached, leaving a space at the top of each pillar for the keystone. Once the firebox has been constructed, line the interior with a thick layer of clay (Figure 5.4).

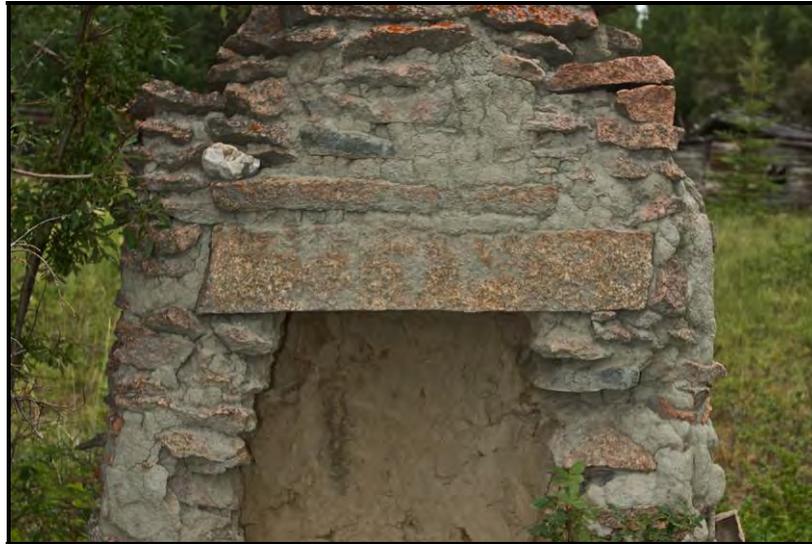
Figure 5.5

Once the body has been built up to the height of the keystone, place the keystone spanning the firebox and cement in place with clay (Figure 5.5)

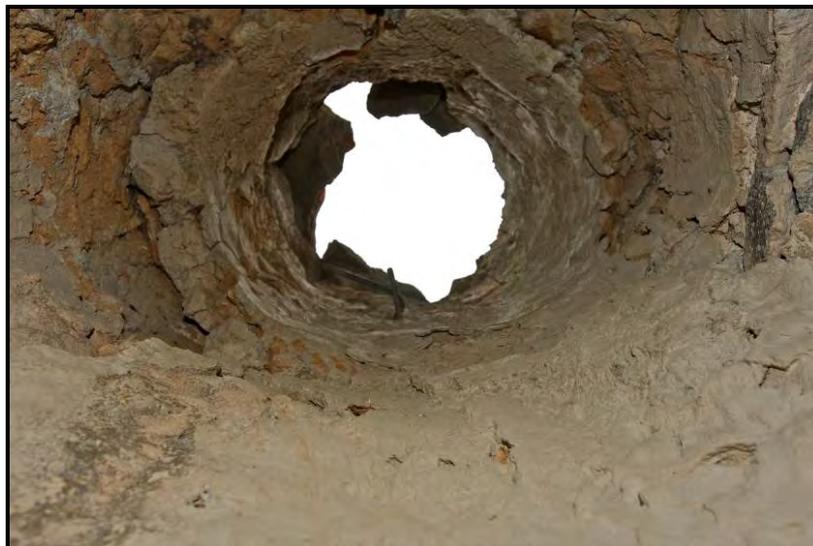
Figure 5.6

Continue building the chimney up layer by layer. During this portion of construction ensure a smooth transition from the interior of the firebox to the round chimney and an adequate layer of clay is lining the chimney (Figure 5.6). It should be noted there is an option to install a metal rod across the middle of the interior of the chimney for future use to hang cooking utensils. The chimney must extend through the roof of the cabin.
